New York State Department of Transportation

Yellow Flag NB2258W004

BIN: 1065318

Gowanus Expressway
2022 Biennial Inspection - Field Sketch

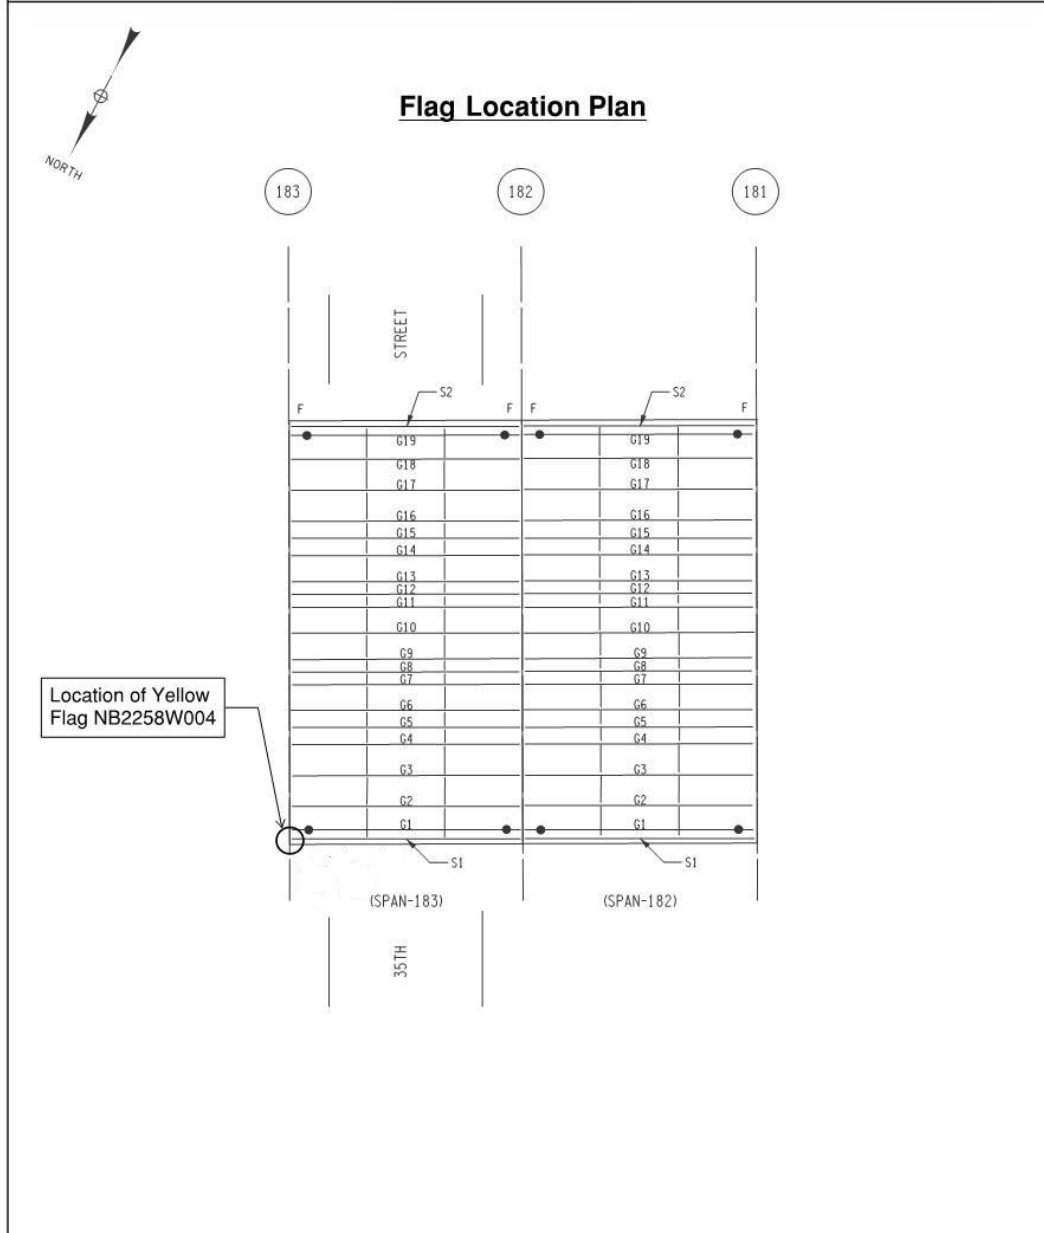
Photo Number: **1**Photo Filename: **22_Flag Location Plan.jpg**

Attachment Description: Flag Location Plan

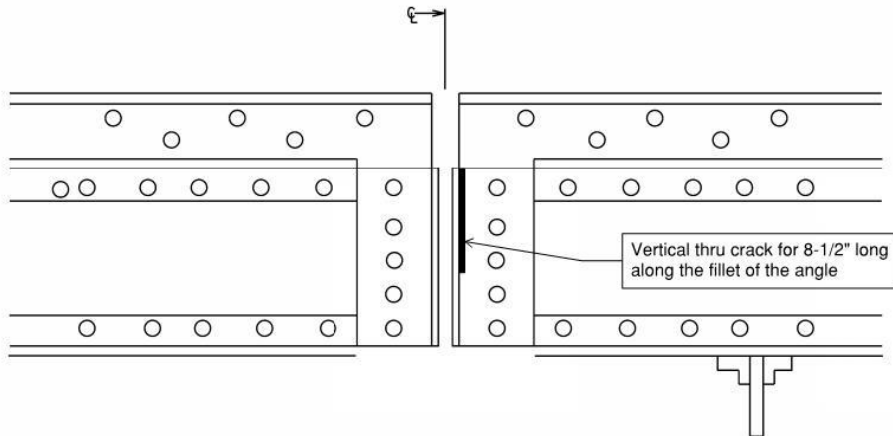
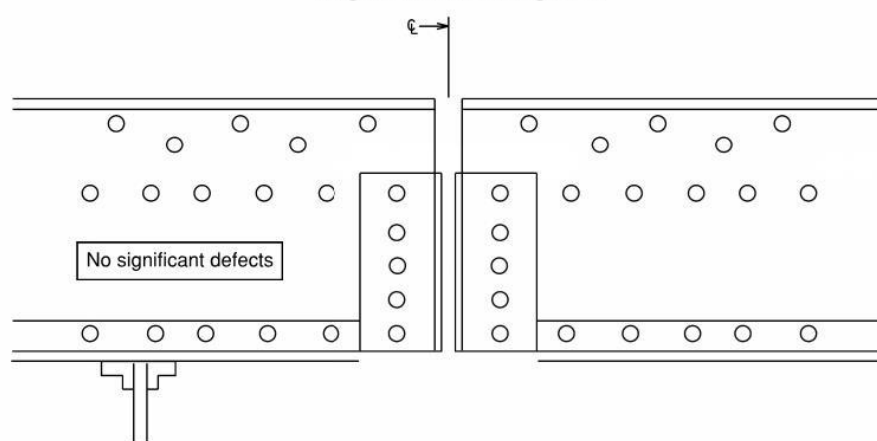
Photo Number: 2

Left Face of Stringer S1

**Right Face of Stringer S1**

Notes:
-Steel reinforcement plates and angles previously installed at
stringer web not shown for clarity purposes.

Attachment Description: Yellow Flag Condition Sketch

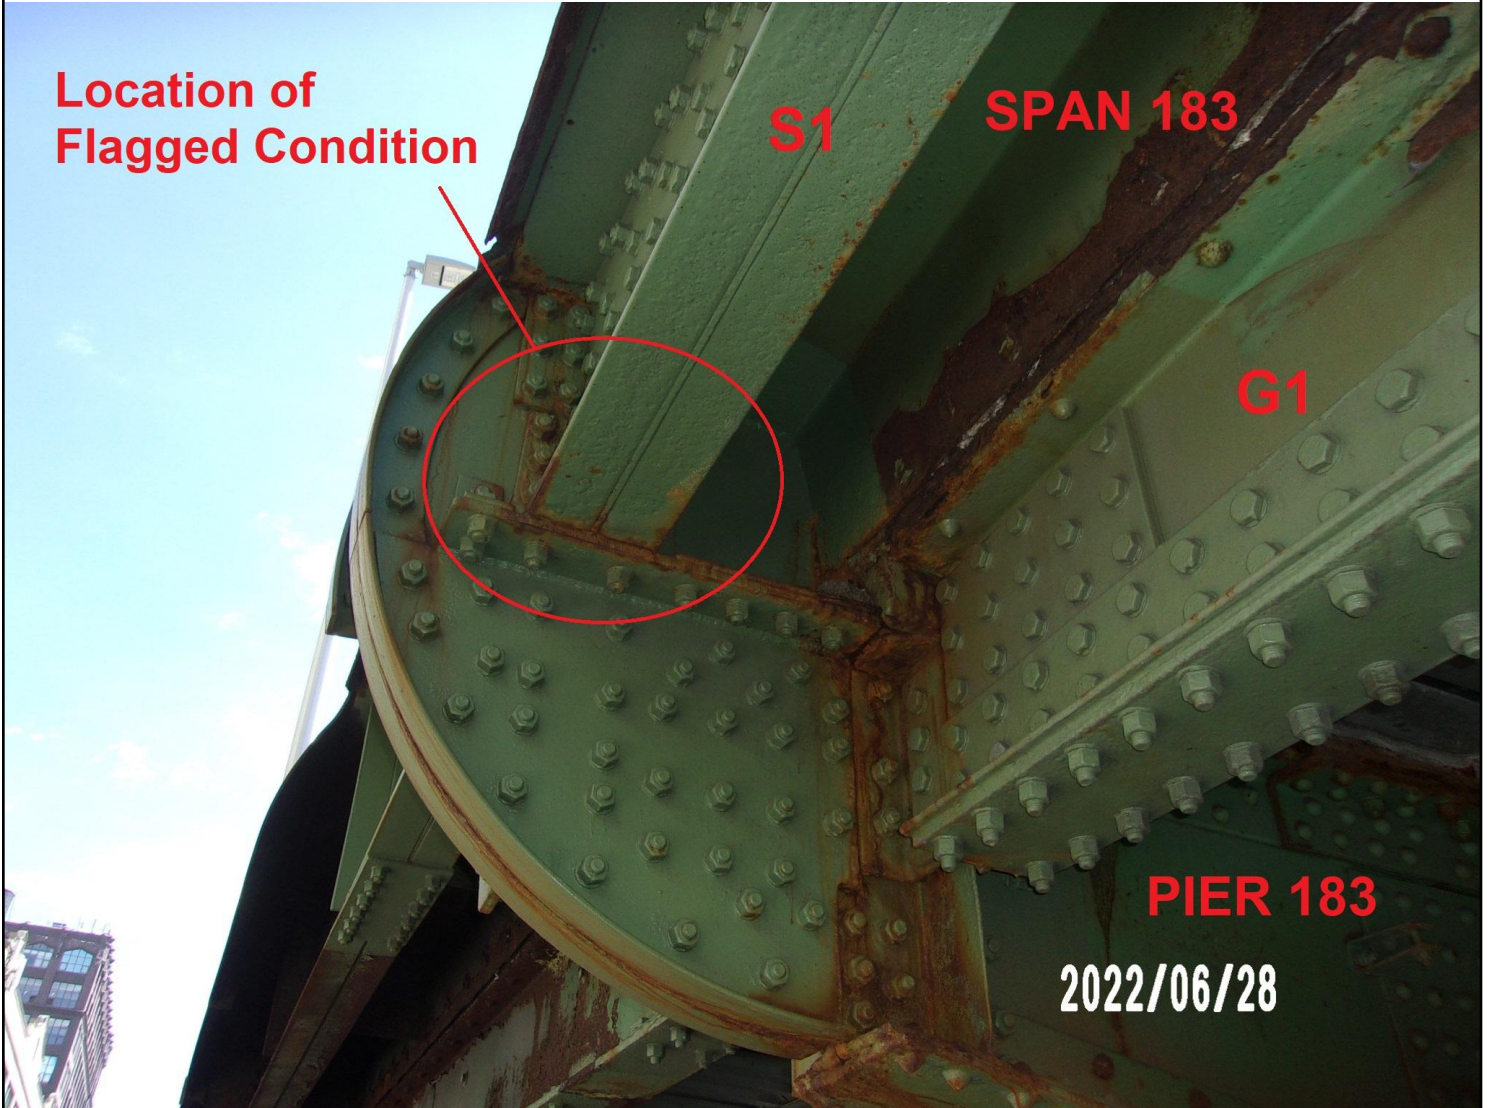
Photo Number: 3

Attachment Description: General view of the flagged condition at Stringer S1 in Span 183 at Pier 183. Looking End.

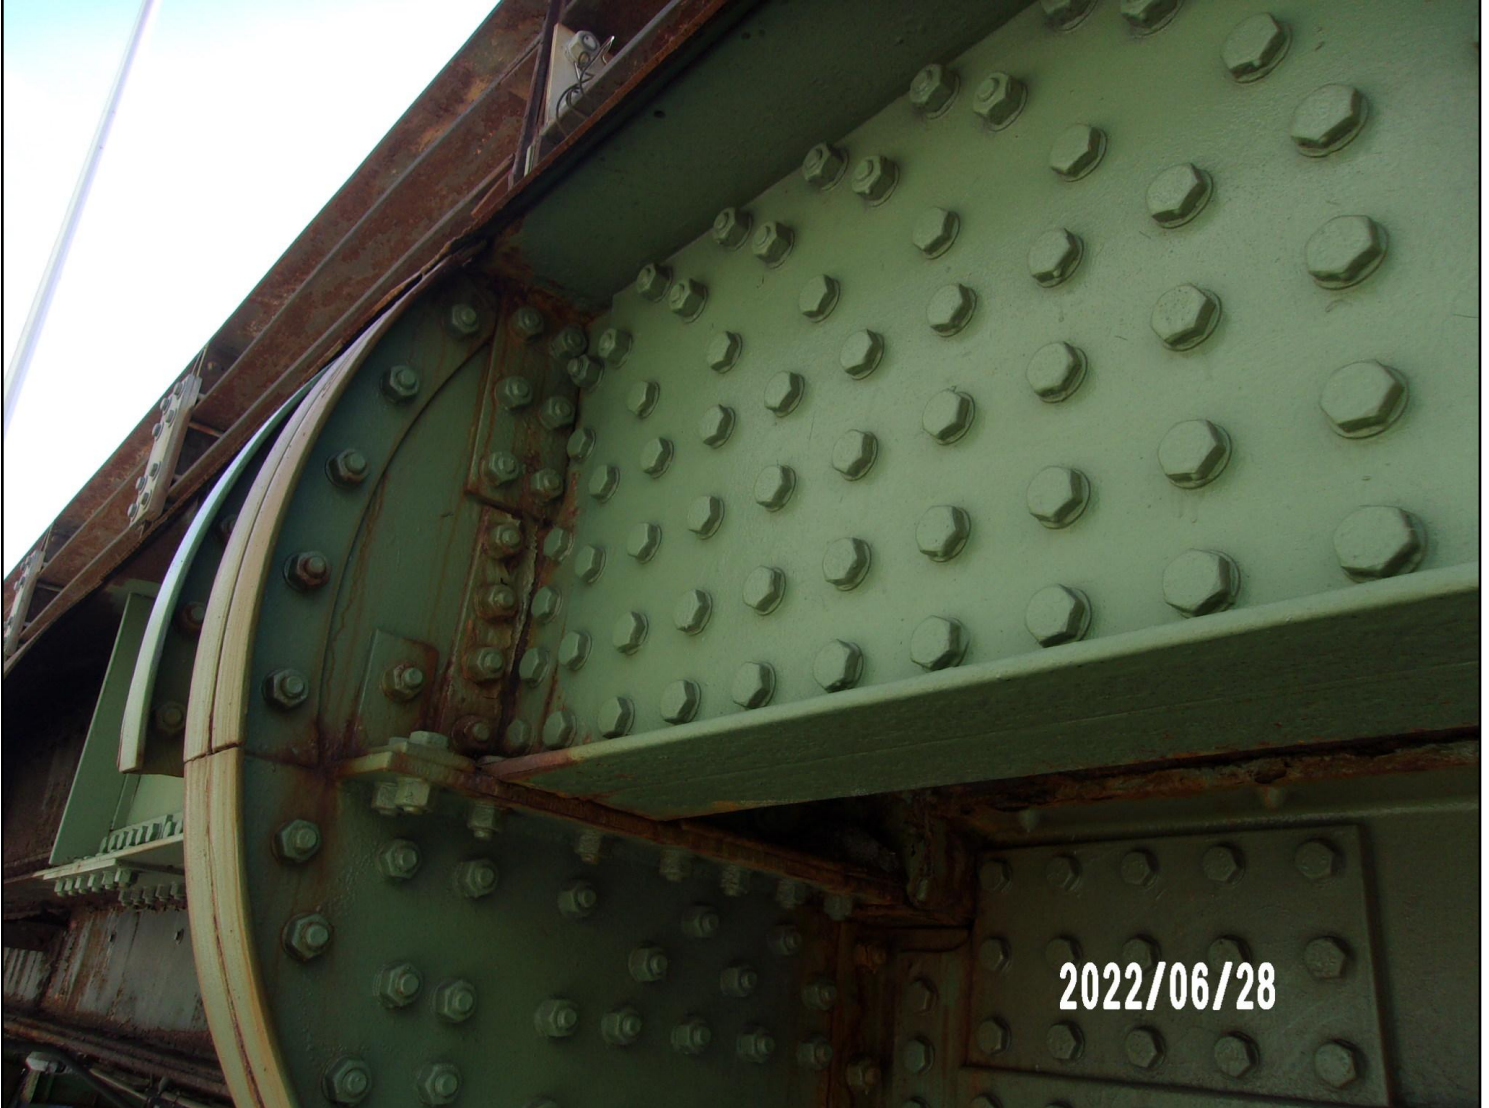
Photo Number: 4

The stringer end at the pier has previously installed steel reinforcement plates and angles which exhibit no significant defects (Photo 4) and the stringer bottom flange is connected to the pier top flange with no significant defects at the connection (Photo 6).

Attachment Description: The left face of Stringer S1 in Span 183 at Pier 183. General view of the steel reinforcement plates and angles at the stringer. Looking End and Right.

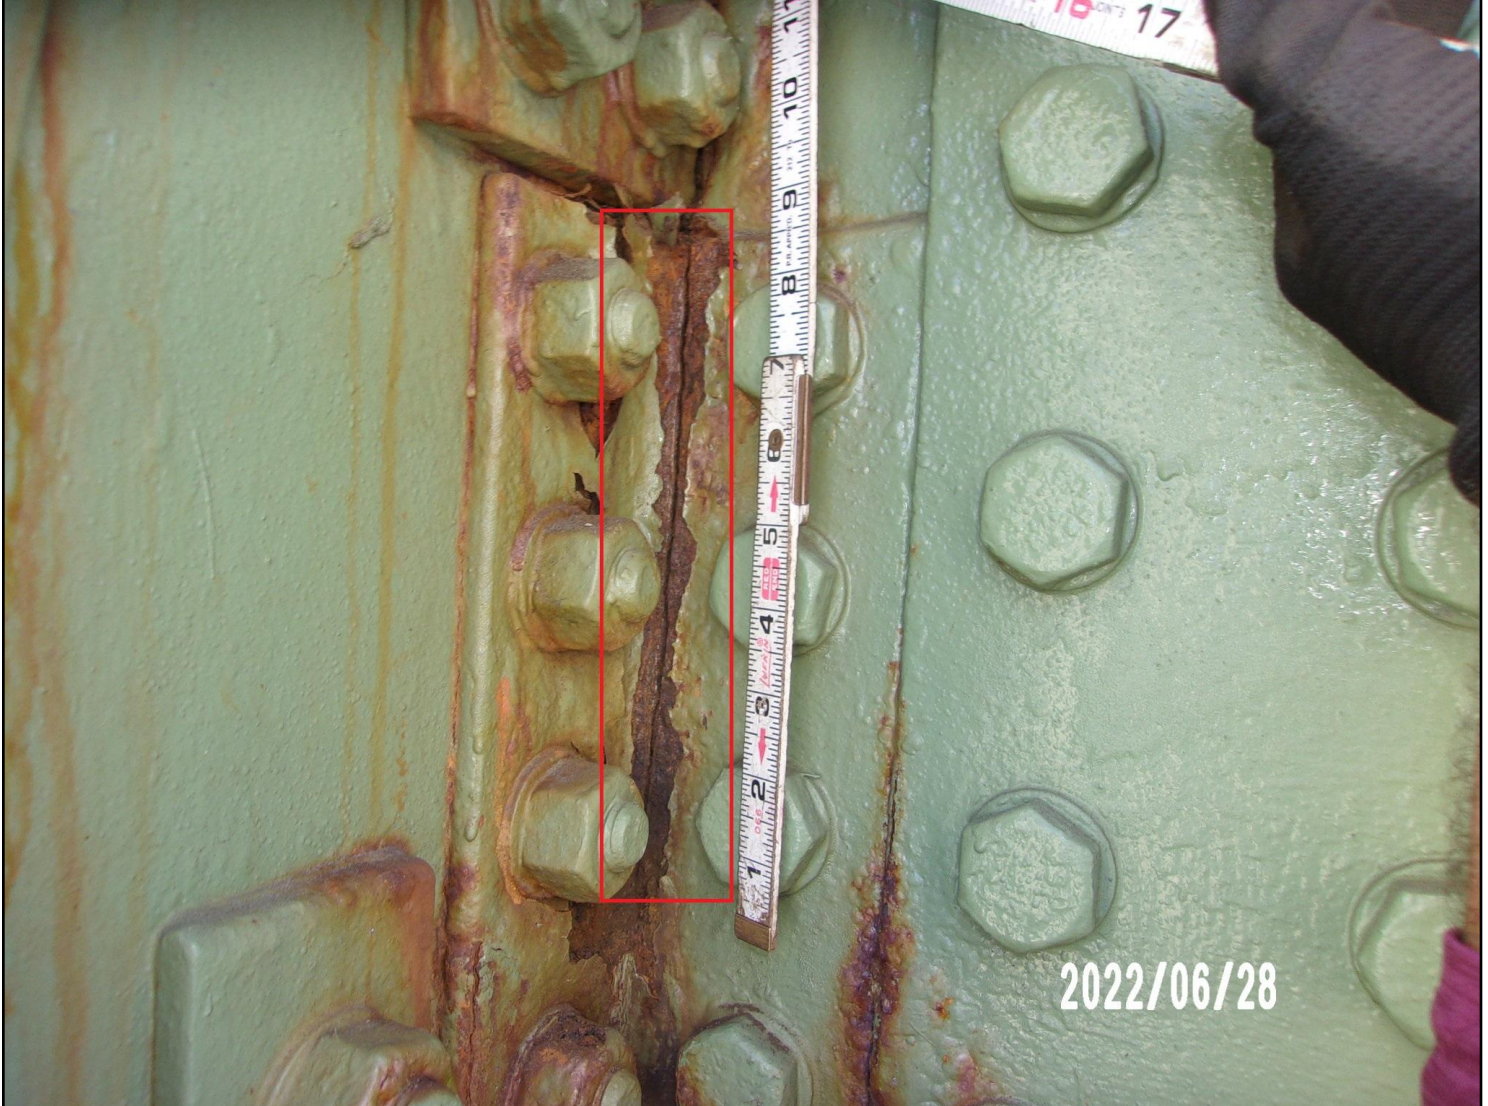
Photo Number: 5

Description: The left connection angle at Stringer S1 in Span 183 at Pier 183 exhibits an 8.5 " long vertical crack in the fillet starting at the top of the connection angle (Photo 5). The right side connection angle exhibits no significant defects.

Attachment Description: The left face of Stringer S1 in Span 183 at Pier 183. The left connection angle exhibits 8.5 " long vertical crack in the fillet starting at the top of the connection angle. Looking End and Right.

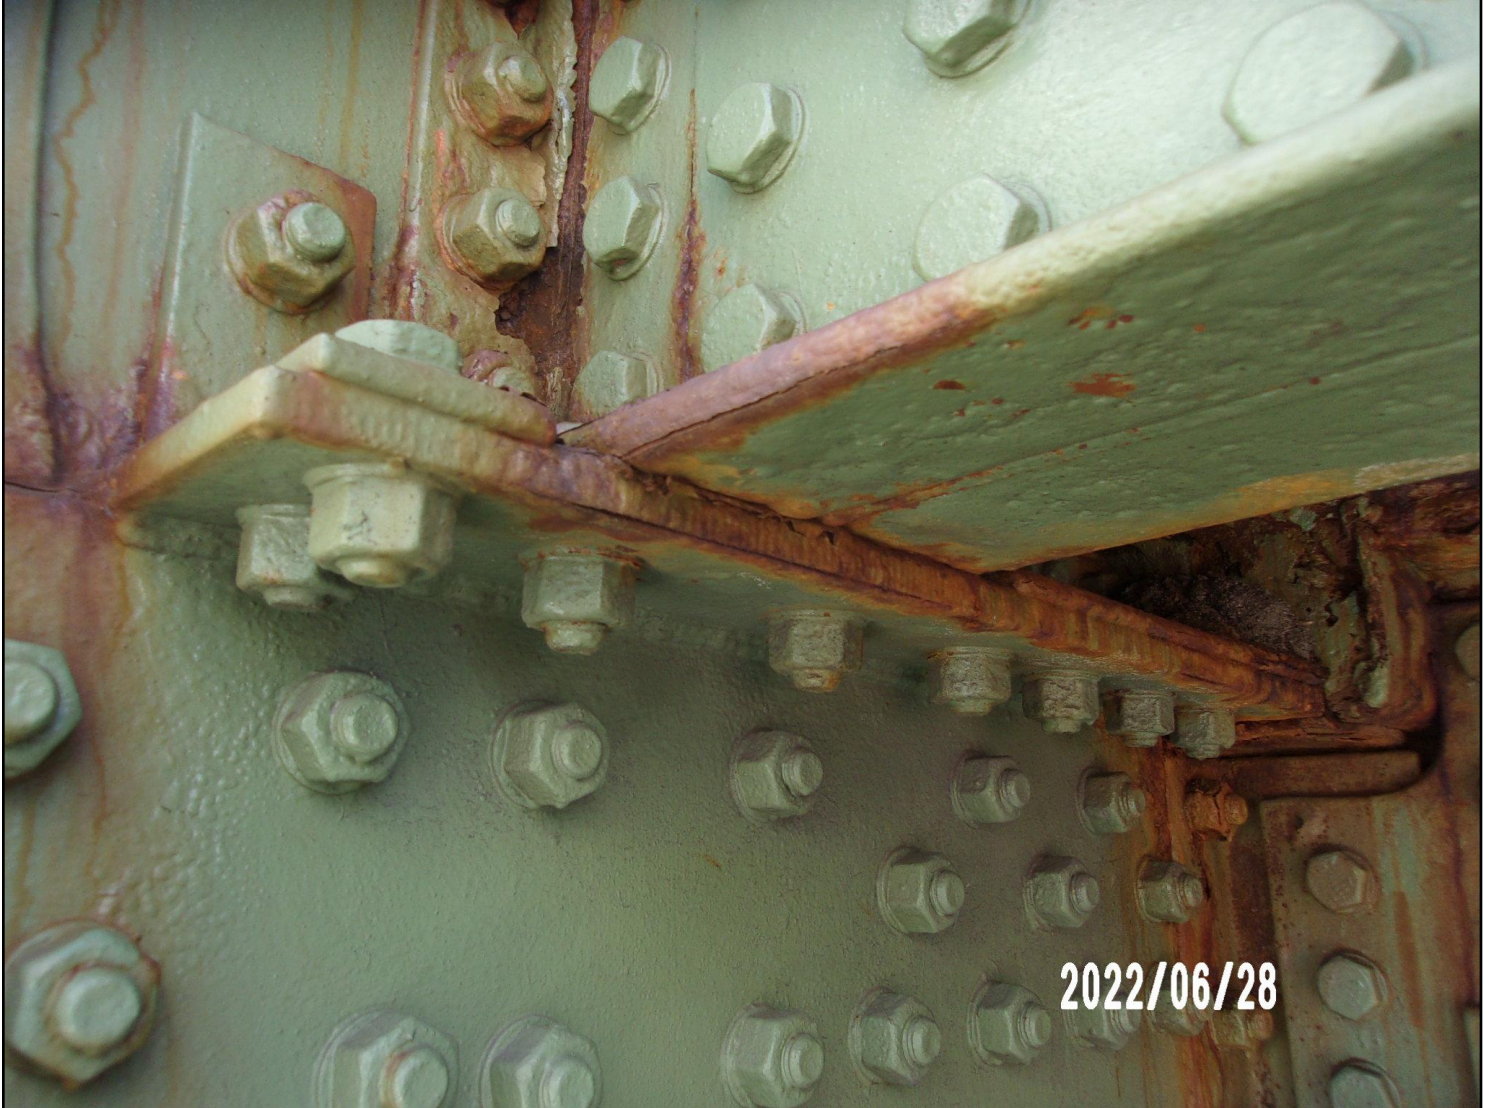
Photo Number: 6

Attachment Description: The bottom of Stringer S1 in Span 183 at Pier 183. The stringer bottom flange connection to pier top flange exhibits no significant defects. Looking End and Right.
